FINAL
KNKT.13.08.22.04

Aircraft Serious Incident Investigation Report

**PT. Lion Mentari Airlines (Lion Air)
Boeing 737-800; PK-LKH
Djalaluddin Airport, Gorontalo
Republic of Indonesia
6 August 2013**

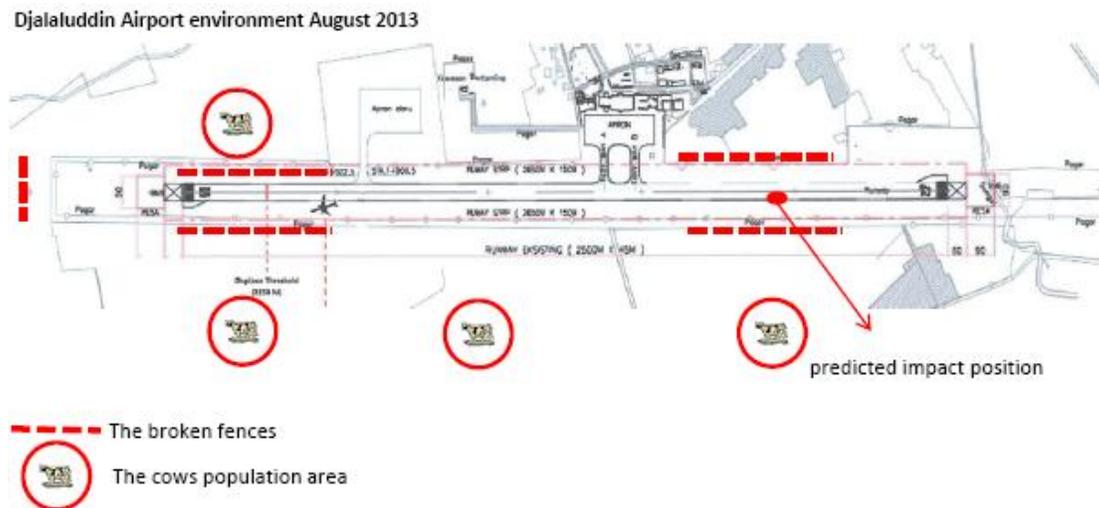
Figure 1. The fences condition and cow population at Djalaluddin Airport on August 2013

- Some fences on the north and south of the runway about 500 meters long were broken and some parts were not installed with the fences.
- The people who living around the airport might enter the airport perimeter and while sometimes might cross the runway through the broken fences.
- Hundreds population of cows were grew and live just outside the airport perimeter, especially along the south of runway.
- The airport management has Bird and animal hazard management as stated in the Aerodrome Manual chapter 4.12.
- The audit by The Directorate of Airport dated 11 July 2013 number: 016/DBU-IK/VII/2013 found that some airport perimeter fences broken and accessible that may increase the wildlife hazard. The investigation could not find any evidence of corrective action program.

The airport layout shows the broken fences and cow's population places are shown in the figure below in the red dash lines and red circles.

The investigation could not find any evidence of corrective action program following the aforesaid audit findings. This was consistent with the observation during the investigation, where some fences at the north and south of the runway about 500 meters long were broken and some parts were not installed with the fences.

- Temporary repair of broken Airport fences.
- Planning for installation of new Airport fences in fiscal year of 2014.
- Increase the frequency security oversight from 10 to 30 times prior to takeoff and landing.
- Airport authority and local government agreed to educate local people to support the safety of aircraft operation by several methods including the installation of precaution placards.

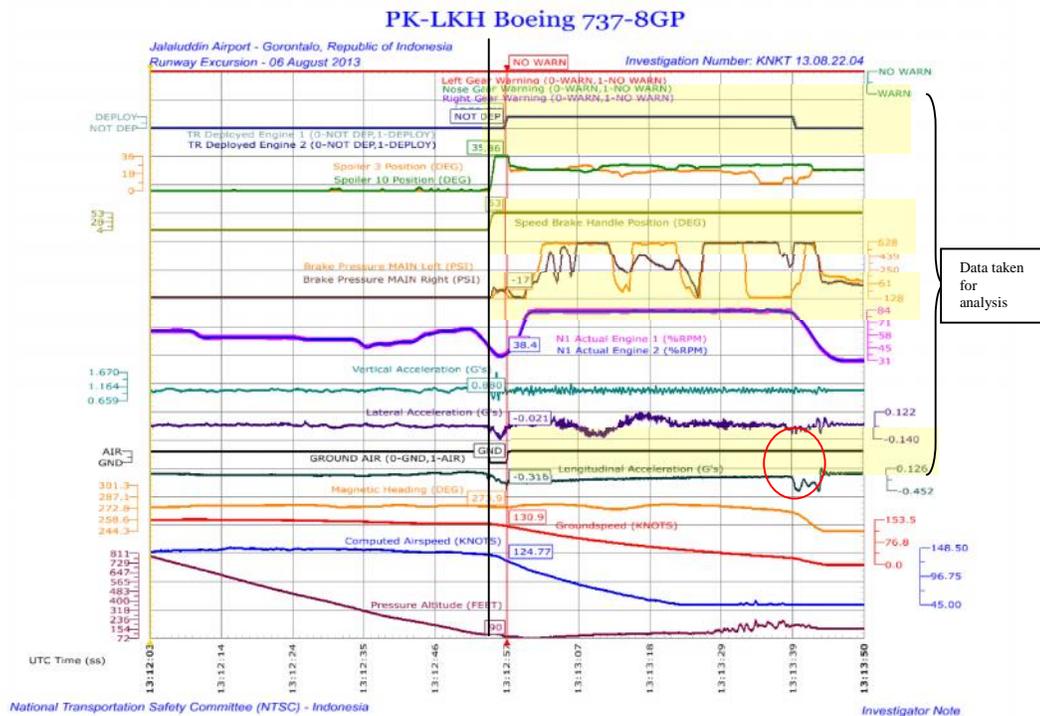
Figure 2. FDR data

The excerpts of significant data from the FDR when aircraft initial touch down on the runway are as follow;

- The spoilers, reversers were applied after touchdown.
- The longitudinal acceleration at initial aircraft touchdown was -0.316 G/sec than was gradually reduced to approximate 0.200 when stop.
- And the initial activation, the right brake pressure was indicated 439psi while the left brake was indicated 628psi.

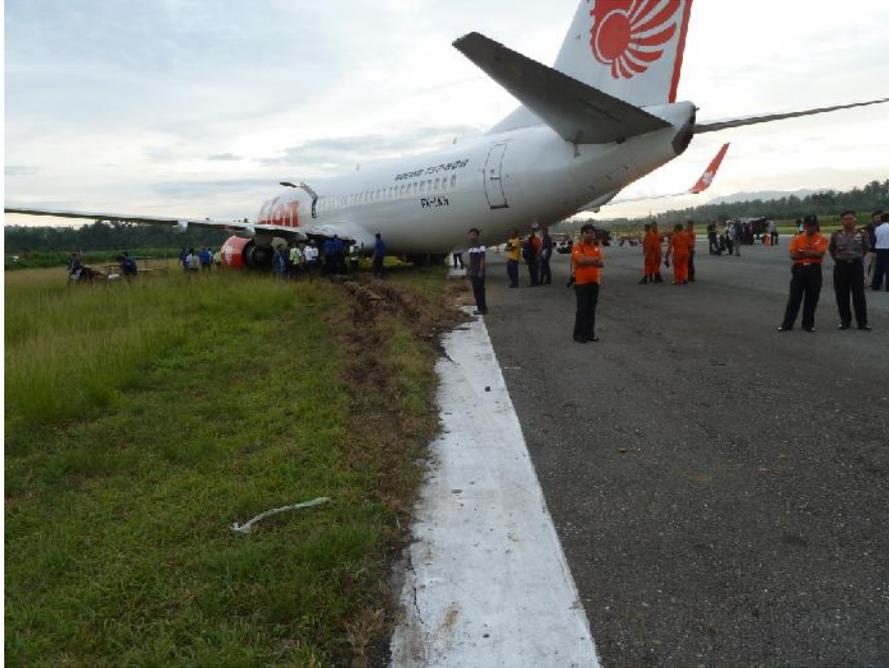
Figure 3. The aircraft out of the runway

Afterward, the pilots felt ineffective of brake respond and then the aircraft veered off to the left and trapped on the left side of the runway shoulder at about 2,100 meters from the beginning of runway 27.

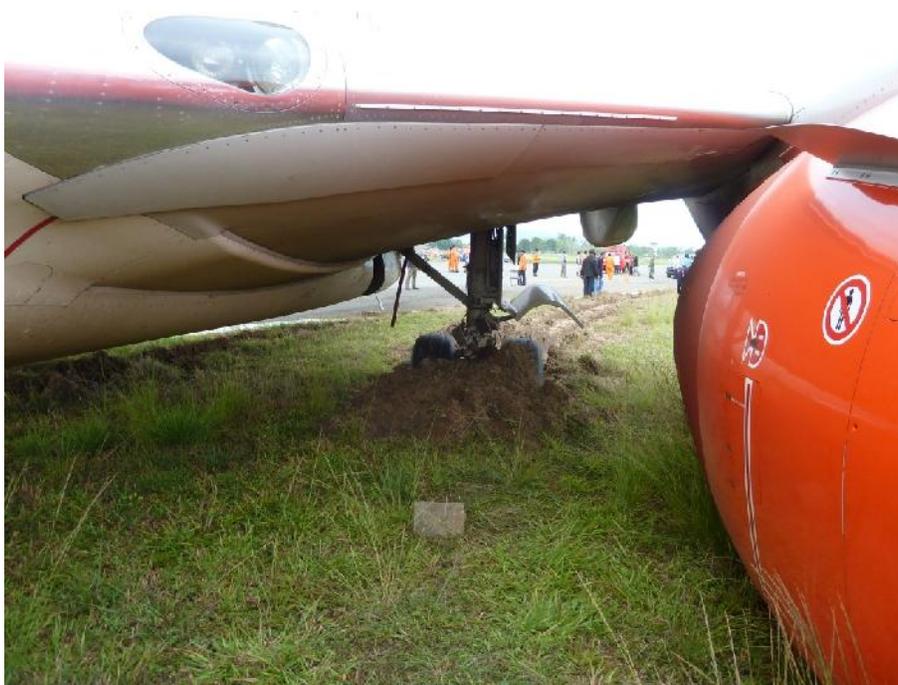
Figure 4. The aircraft wheels trapped on the shoulder

- i. The strength of the shoulder could not support when the aircraft run off the runway.
- j. The people living around the Airport, enters the Airport perimeter and sometimes cross the runway through the broken fences.
