FINAL INCIDENT REPORT 5Y-SIB 04.01.2015

FOKKER 27-50
JOMO KENYATTA INTERNATIONAL AIRPORT
NAIROBI

CIVIL AIRCRAFT FINAL ACCIDENT REPORT

REGISTRATION : 5Y-SIB

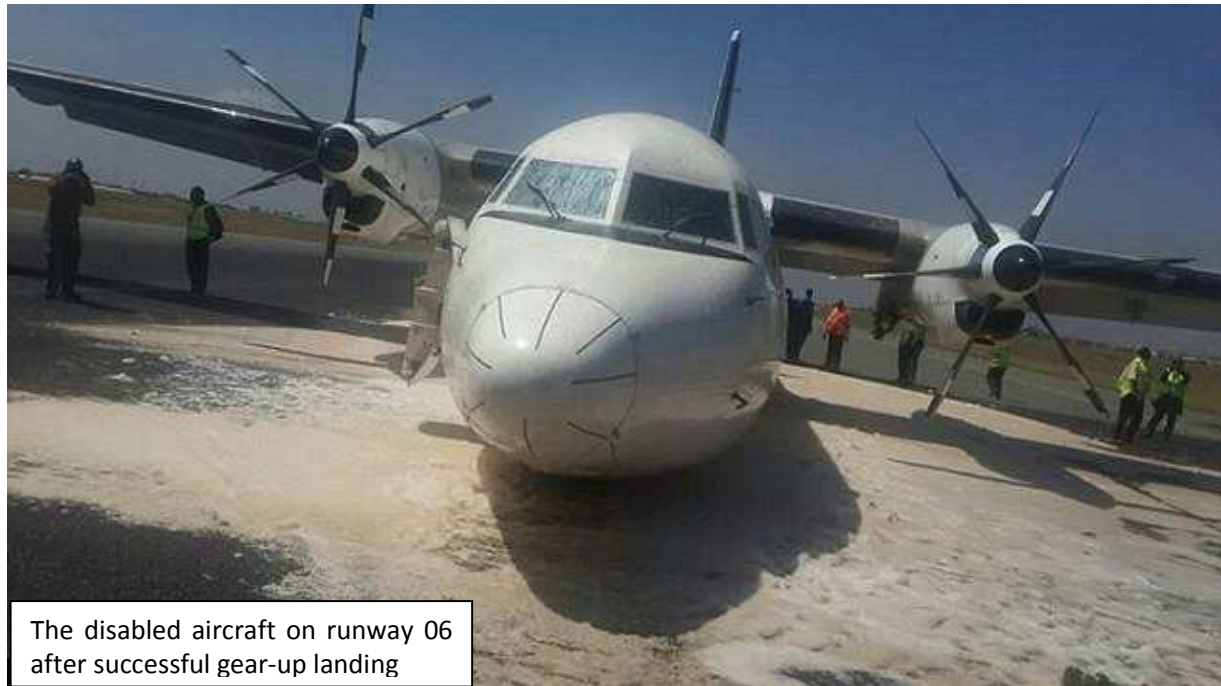
Figure 1:A photograph showing the disabled aircraft on the runway after gear-up landing

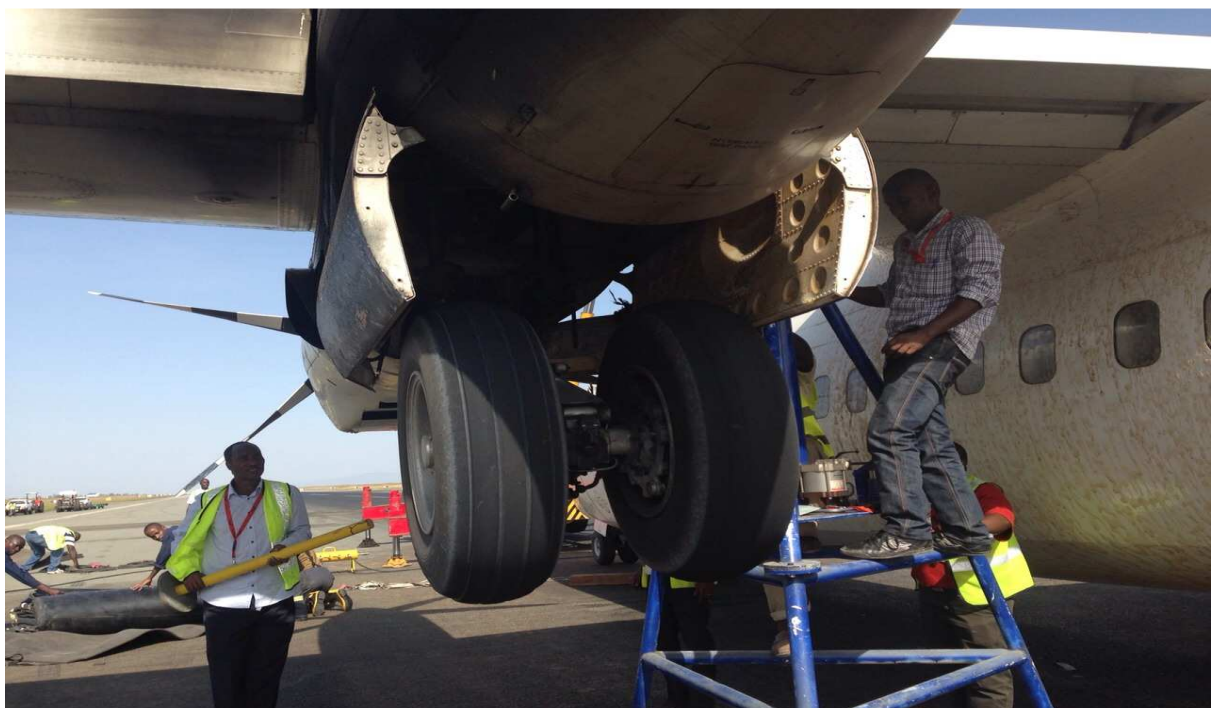
Figure 2: A photograph showing an engineer pulling the left MG down

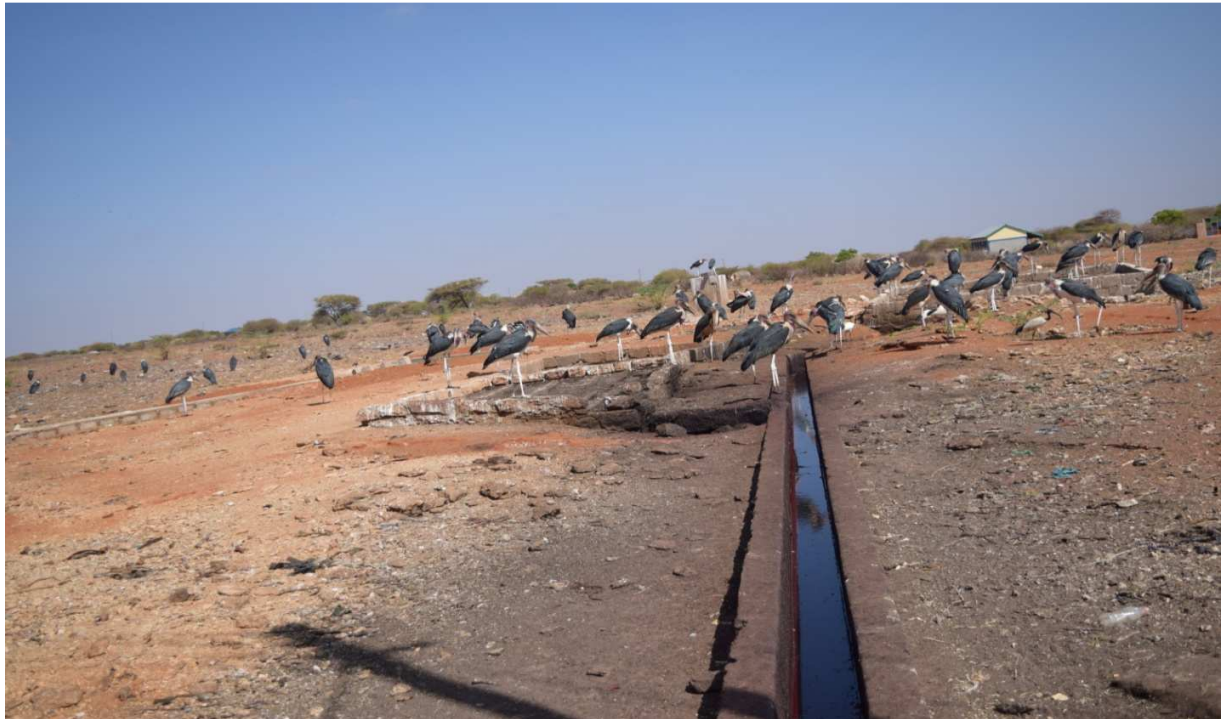
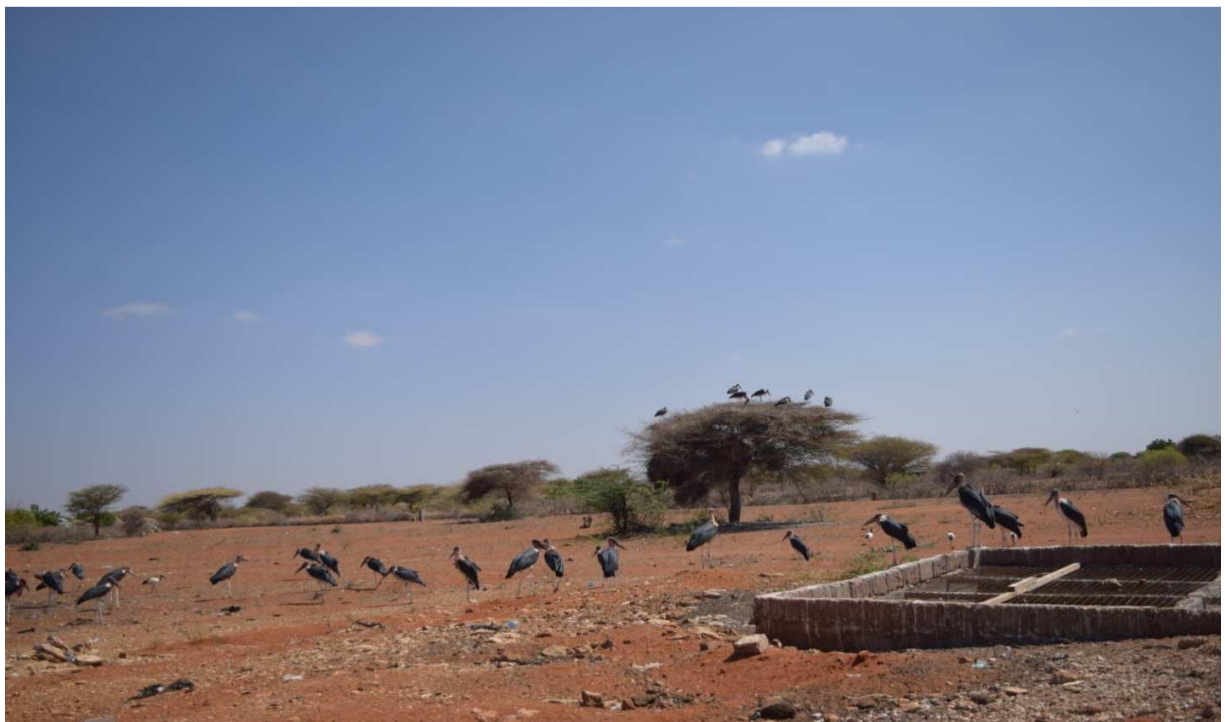
The above Google map shows major bird/wildlife attractants around Wajir airport. Major Attractants are Wajir slaughterhouse, Lake Yahud, New quarry, new co-located sewerage and damping site. There are also other attractants within the airport such as swamp water mash, grass and bushes. All the attractants sites fall less than 7km radius from the aerodrome reference point (ARP). Lake Yahud is the nearest at 1.67km from ARP and less than 0.66km from end of runway 15.

Figure 4: A photograph showing a flock of birds feeding at Wajir slaughterhouse

- 4.6 HKWJ should explore the need to acquire new predictive and real-time bird avoidance systems such as avian radar to supplement the bird control hazard management programs at the airport.

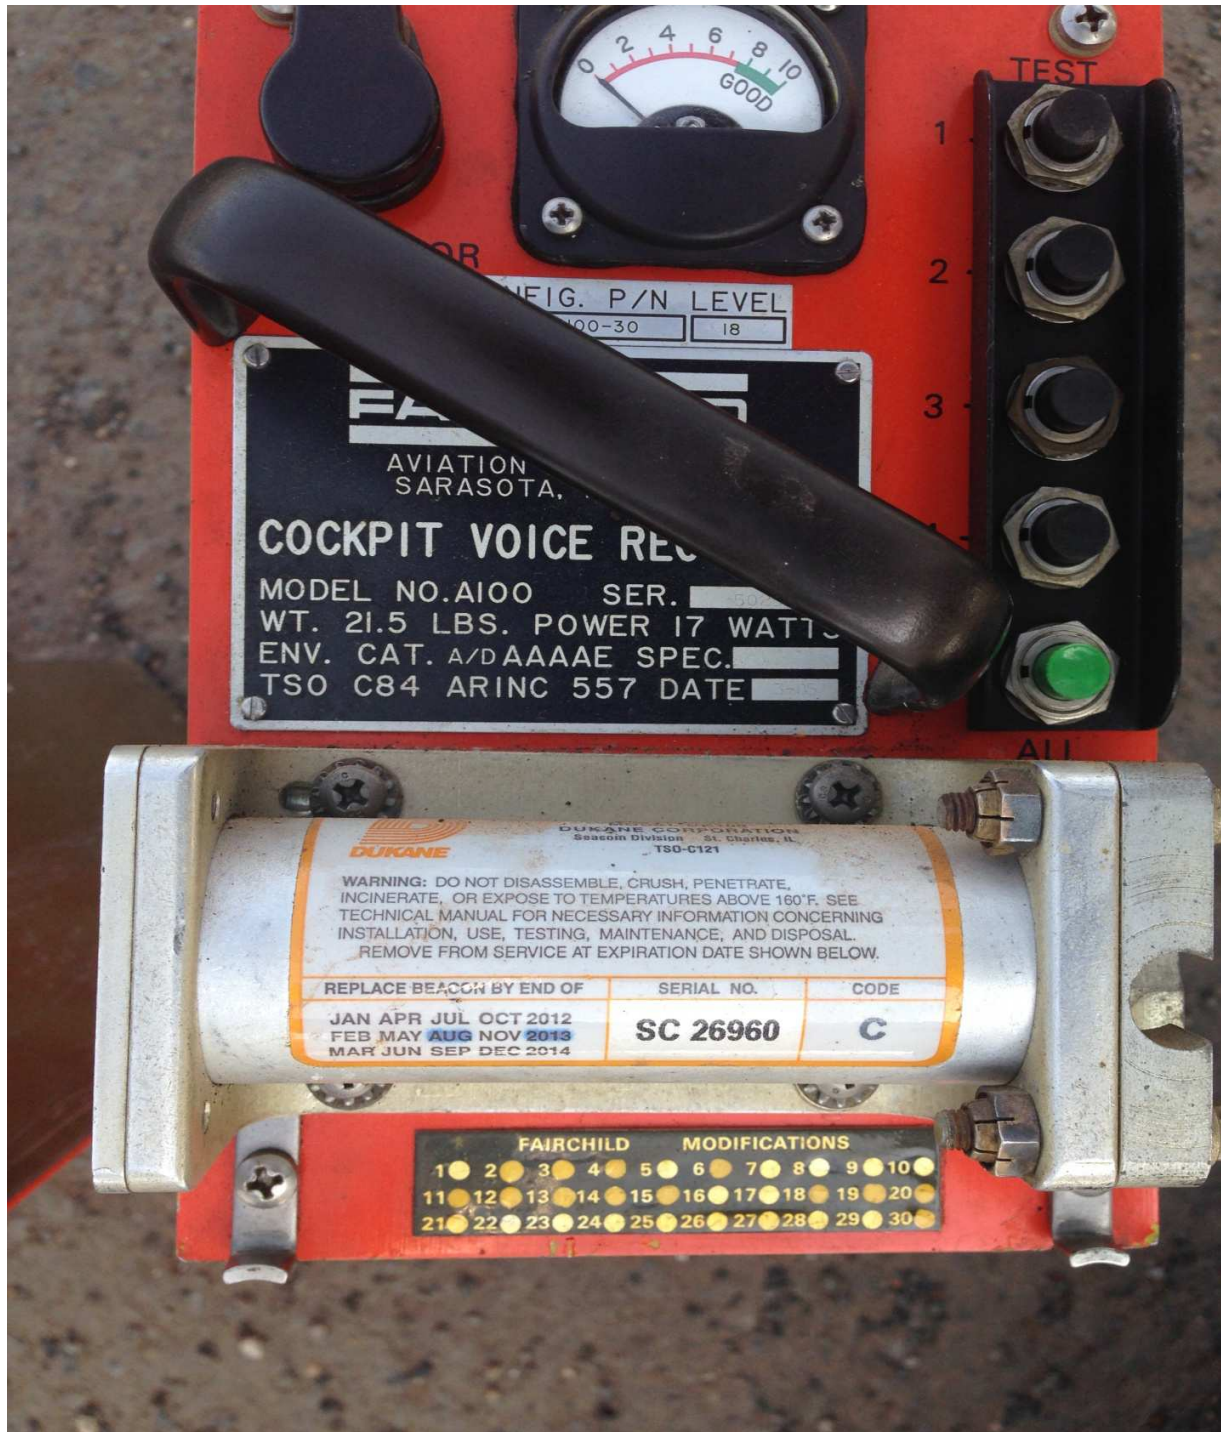
The aircraft was equipped with Fairchild Model A100 Solid-State Cockpit Voice Recorder (CVR). The CVR was taken to United Arab Emirates (U.A.E) General Civil Aviation Authority laboratory for readout and evaluation. There was no significant data extracted from the CVR during readout that was consistent with the flight as it was not functional.

Figure 5: A photograph showing the Cockpit Voice Recorder

- 4.2 Since information on the CVR installed in the aircraft could not be obtained due to equipment malfunction it is recommended that:

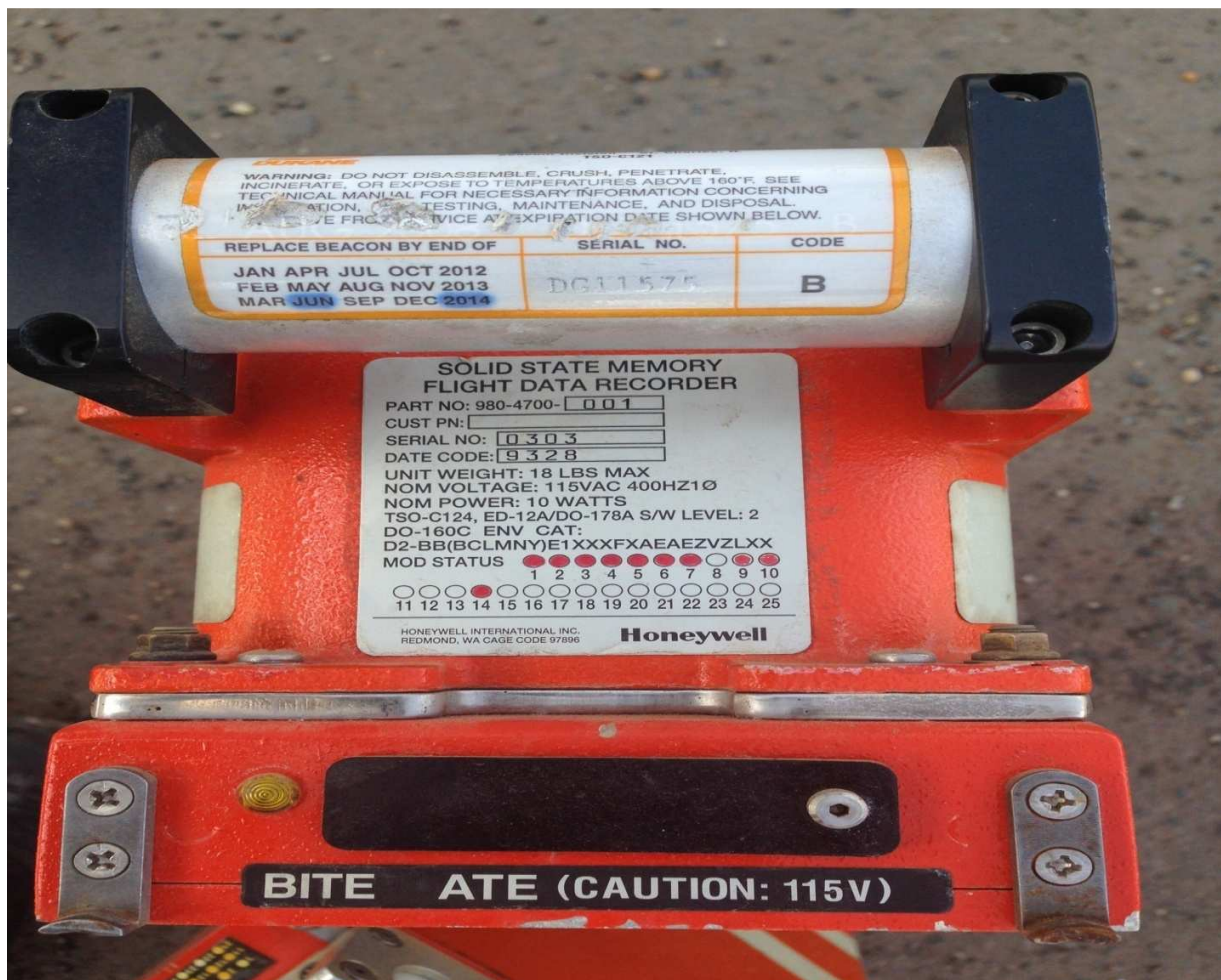
The aircraft was equipped with a Honeywell model 980-4700 solid-state FDR. Just like the VCR the FDR was also taken to United Arab Emirates (U.A.E) General Civil Aviation Authority laboratory for a readout and evaluation. The raw data was extracted but could not be analyzed at the laboratory because of lack of Data Frame Layout documentation. The raw data extracted was sent to Netherlands for evaluation. The result was sent back to AAID with six parameters of aircraft flight information for the entire accident flight.

Figure 6: A photograph showing Flight Data Recorder

- 4.3 Since Data Frame Layout and FDR calibrations documents could not readily be obtained during FDR read-out at U.A.E it is recommended that:

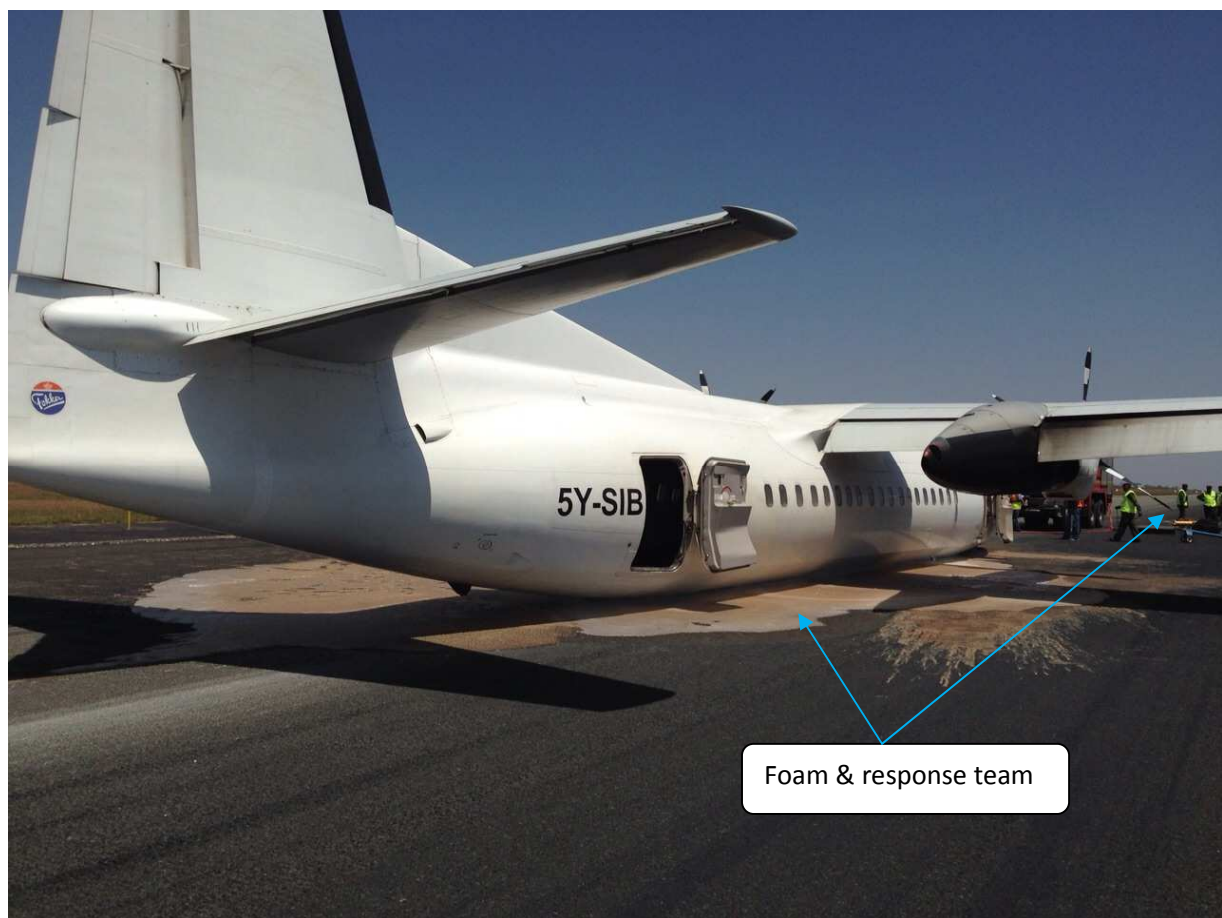
The first evidence of ground impact was located 200m from threshold runway 06 along the runway centerline. The aircraft rolled on its belly leaving a trail of fuselage fairing and broken pieces of the main fuselage along its track. The wreckage was found 950m from threshold runway 06 near taxiway F. The main wreckage consisted all parts of the aircraft structure including the landing gear which was still in up position. Figure 7 shows the main wreckage and fire foam sprayed by RFF response unit.

Figure 7: A photograph showing the wreckage of the aircraft on the runway

The aircraft stopped a distance of 750 m after first impact with the ground. There was extensive damage on its lower fuselage (belly) as it left a trail of broken pieces from the fuselage. The passenger door on the forward LH failed to open because of its contact on the ground owing to its structural position on the aircraft. There was also a dent on the door to the left MLG and one broken strut that mechanically aids the closing and opening of the door of the left MLG.

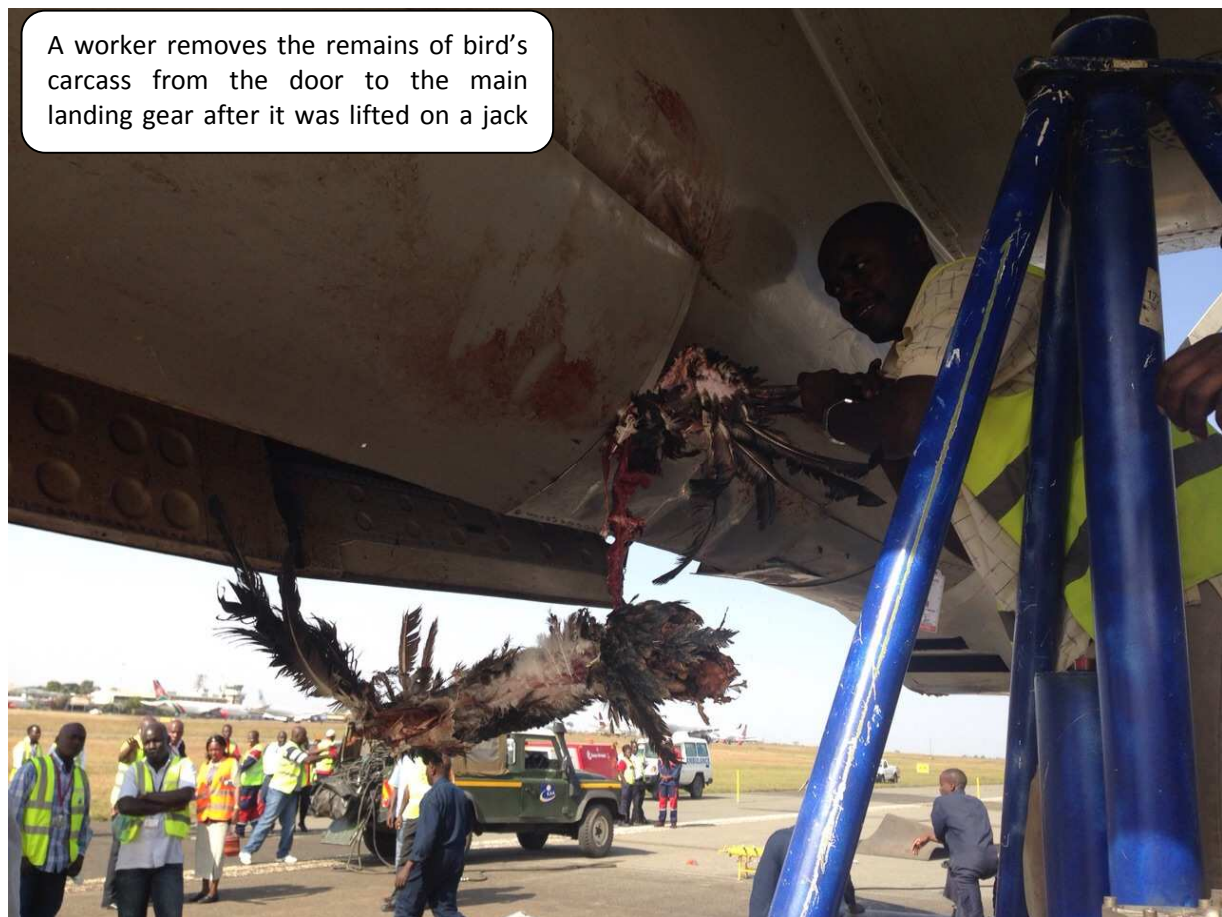
The left Main Landing Gear (MLG) was found still up position and the carcass of MSwedged onto the door of the left main landing gear. There was a dent to the door of the left MLG with scattered stain of blood from the bird's carcass. A close examination revealed that one the struts

Figure 8: A photograph showing an engineer removing the bird's Caracas from the left MLG

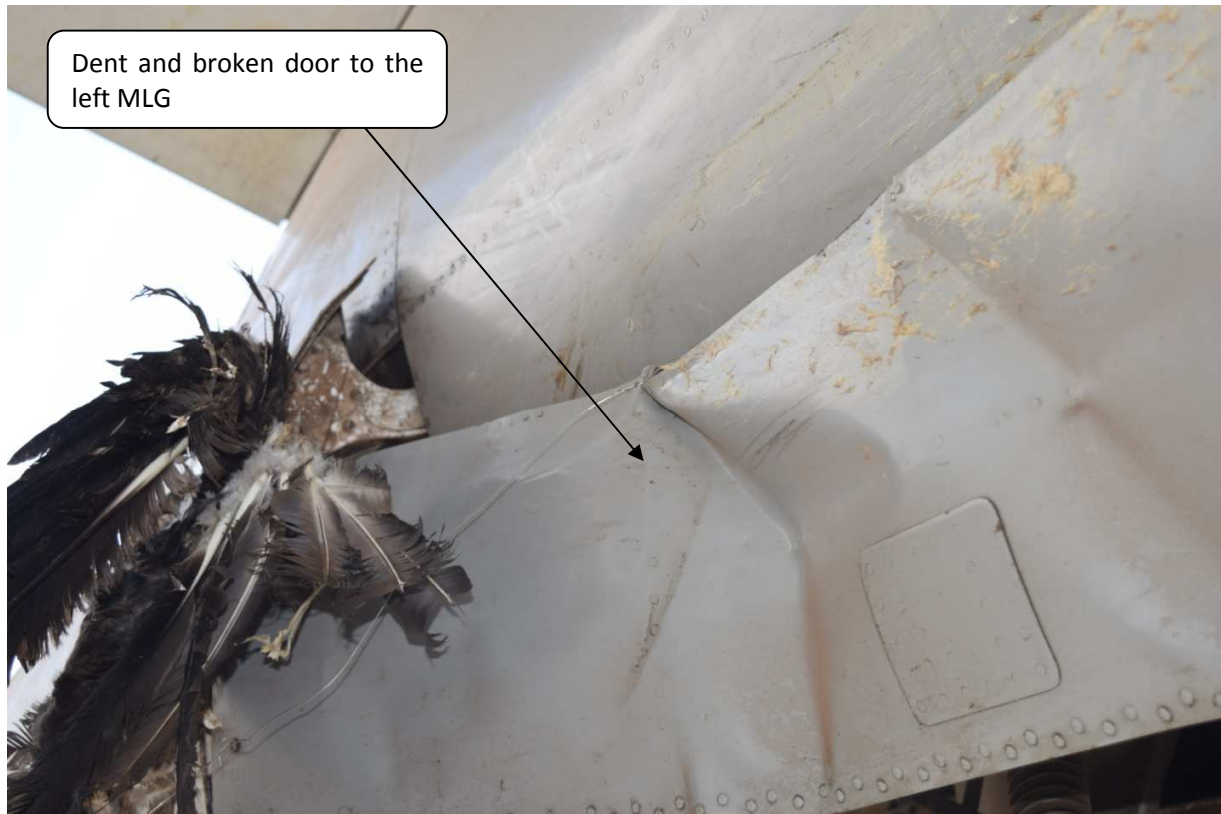
Figure 9: A photograph showing damage on the door to the left MLG

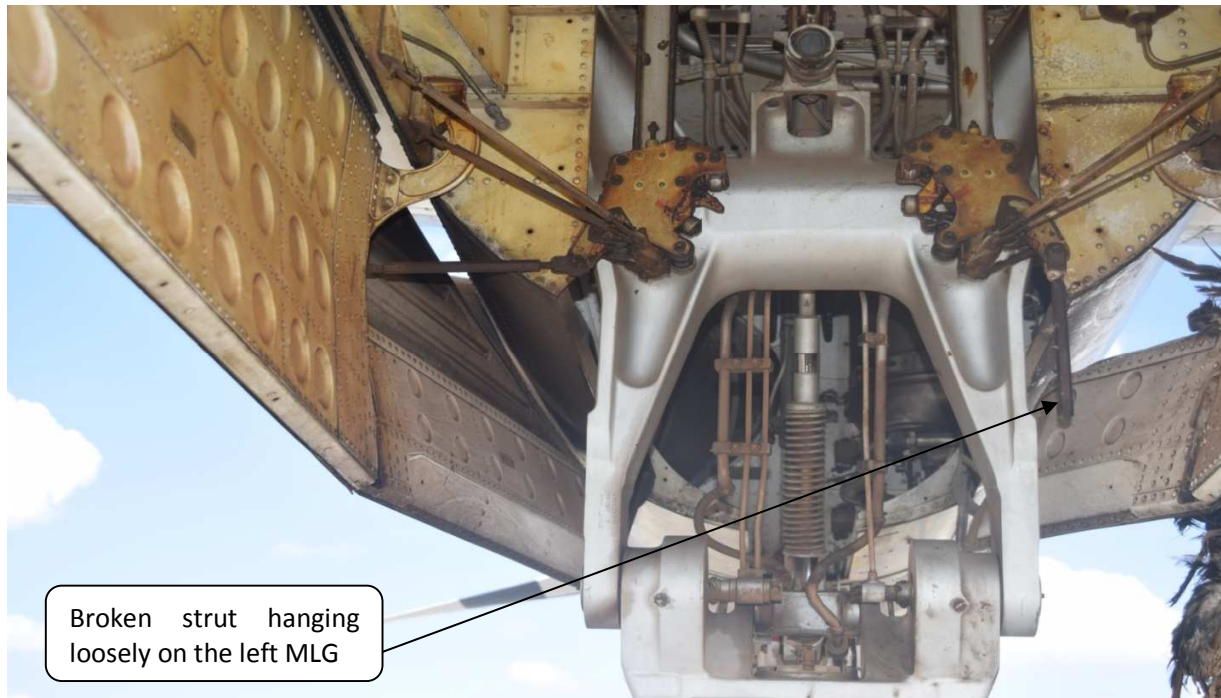
that mechanically aid the closing and opening of the door of the left MLG was broken (See figure 10 below).

Figure 10: A photograph showing the left MLG with a broken strut

The cause of the accident was the failure of the left Main Landing Gear,MLGto extendduring landing due to a bird strike which disabled proper functioning of the mechanical system that controls the opening and closingthe door to theleft MLG.

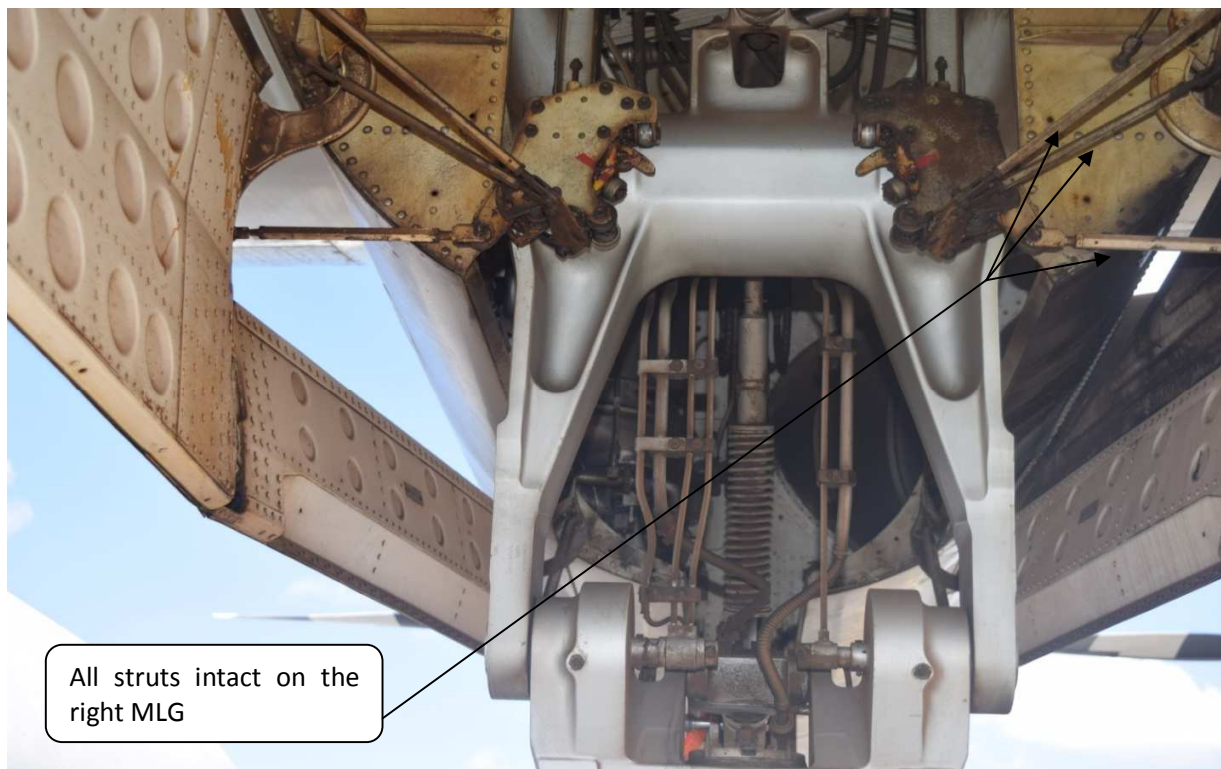
The right MLG was on gear-up and remained intact. All components on the right MLG were also found intact and attached to the main gear assembly. The nose landing gear (NLG) was also on gear-up position and intact. All components of the NLG were found intact and attached to the gear assembly.

Figure 11: A photograph showing the right MLG with all the struts intact and in position
