## **Birds at Milan Linate**

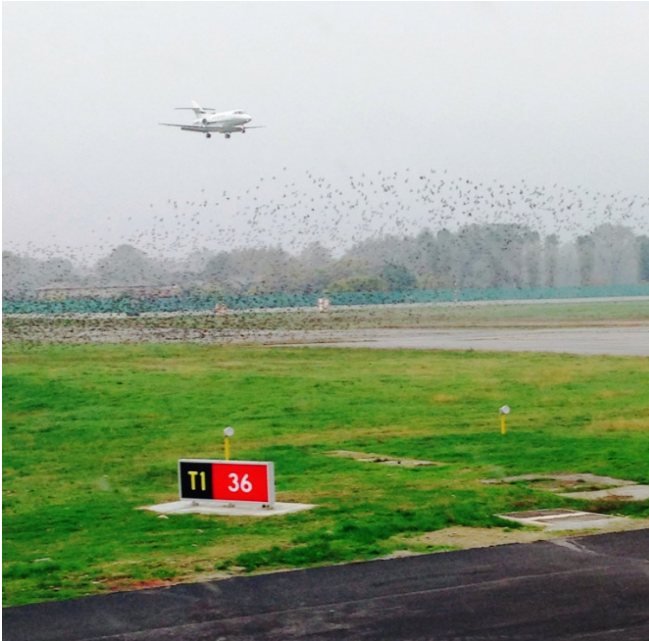
Monday the 28th of October, about 08:00 AM, holding point on taxiway T1 of Milan Linate airport. The photo speaks for itself: a small jet plane is on short final while a murmuration of starling is taking off and crosses the runway extension. Other flocks (or maybe the same) had been observed since the previous hour climbing and settling inside the airport and even crossing the runway just in the point where the big liners rotate for take-off. Behind the little airplane there is a sequence of commercial aircraft approaching, while behind the aircraft at the holding point other airplanes are waiting for their turn to take-off: it's a peak hour.

But the fundamental question, in our view, is that birds and airplanes, as seen in the first photo, can not be together in the same airspace: simply they can not (and must not), so there are two possible cases: either the observation and removal system is immediately effective, or aircraft have to go elsewhere or stay on the ground until the danger has passed.

Much has been done since then to improve the safety, but there is still much to do; we take the liberty to suggest to the airport operator to achieve another record, being the first Italian airport to install an avian radar, i.e. a radar that can detect for tactical purposes flocks of birds up to 5 km.

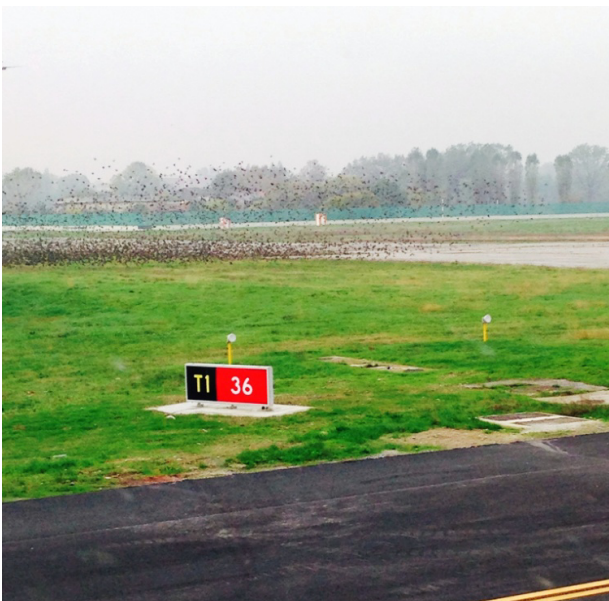
For at least one hour a remarkable number of starlings used Linate airport as a gathering point for the daily excursions into the country in search of food, that's a well known behaviour. During this

period they made the usual movements, flying up and down from the ground. The photo below, taken moments before the first one, provides documentary evidence of this behaviour.

While these photos were taken no bird control patrols have been seen in the area. Air traffic was not suspended waiting for the bird dispersal, and everything was running as usual.
