FINAL
KNKT.13.08.22.04

Aircraft Serious Incident Investigation Report

**PT. Lion Mentari Airlines (Lion Air)
Boeing 737-800; PK-LKH
Djalaluddin Airport, Gorontalo
Republic of Indonesia
6 August 2013**

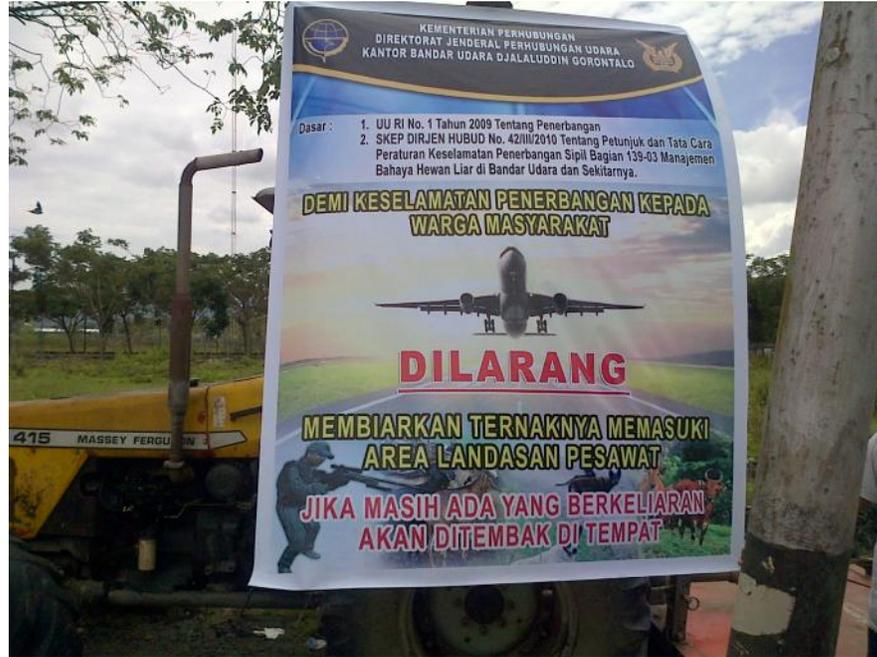
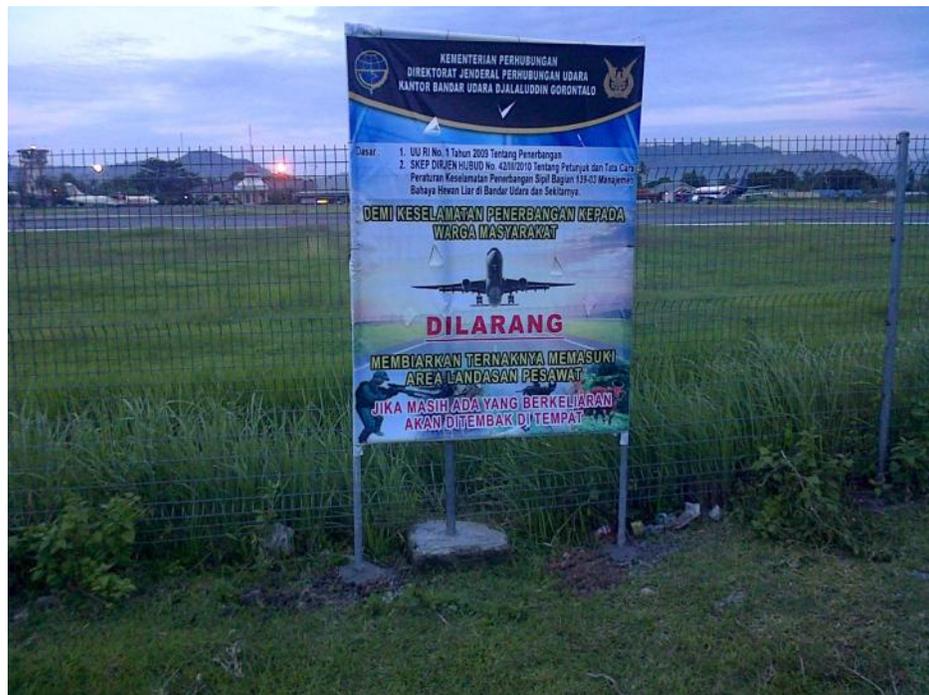
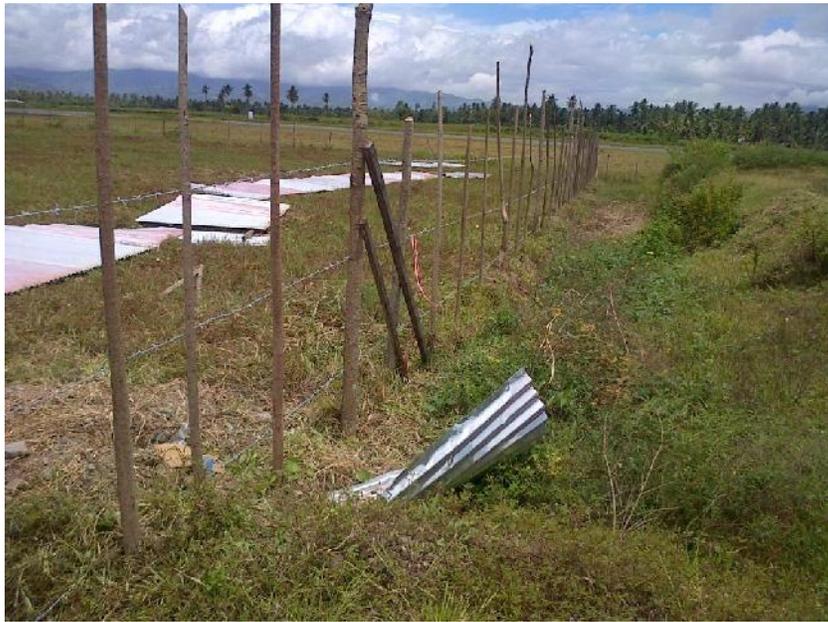
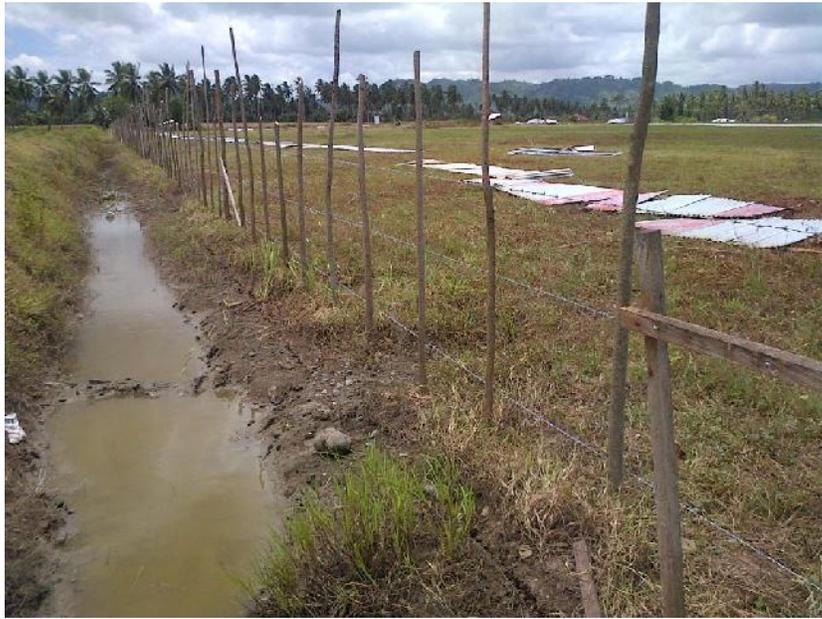
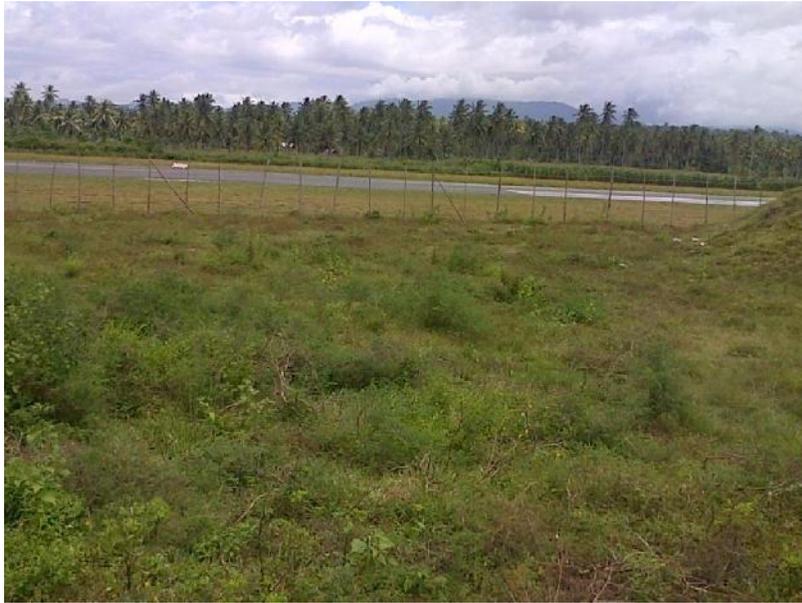
6.1 The design Airport authority Safety action

- Some fences at the north and south of the runway approximately along 500 meters were broken and some parts were not installed with the fences.
- The Djalaluddin Airport has been audited, as the findings: some Airport perimeter fences broken and the corrective action program did not perform.

- Temporary repair of broken Airport fences.
- Planning for installation of new Airport fences in fiscal year of 2014.
- Increase the frequency security oversight from 10 to 30 times prior to takeoff and landing.
- Airport authority and local government agreed to educate local people to support the safety of aircraft operation by several methods including the installation of precaution placards.
