FINAL INCIDENT REPORT 5Y-SIB 04.01.2015

FOKKER 27-50
JOMO KENYATTA INTERNATIONAL AIRPORT
NAIROBI

CIVIL AIRCRAFT FINAL ACCIDENT REPORT

REGISTRATION : 5Y-SIB

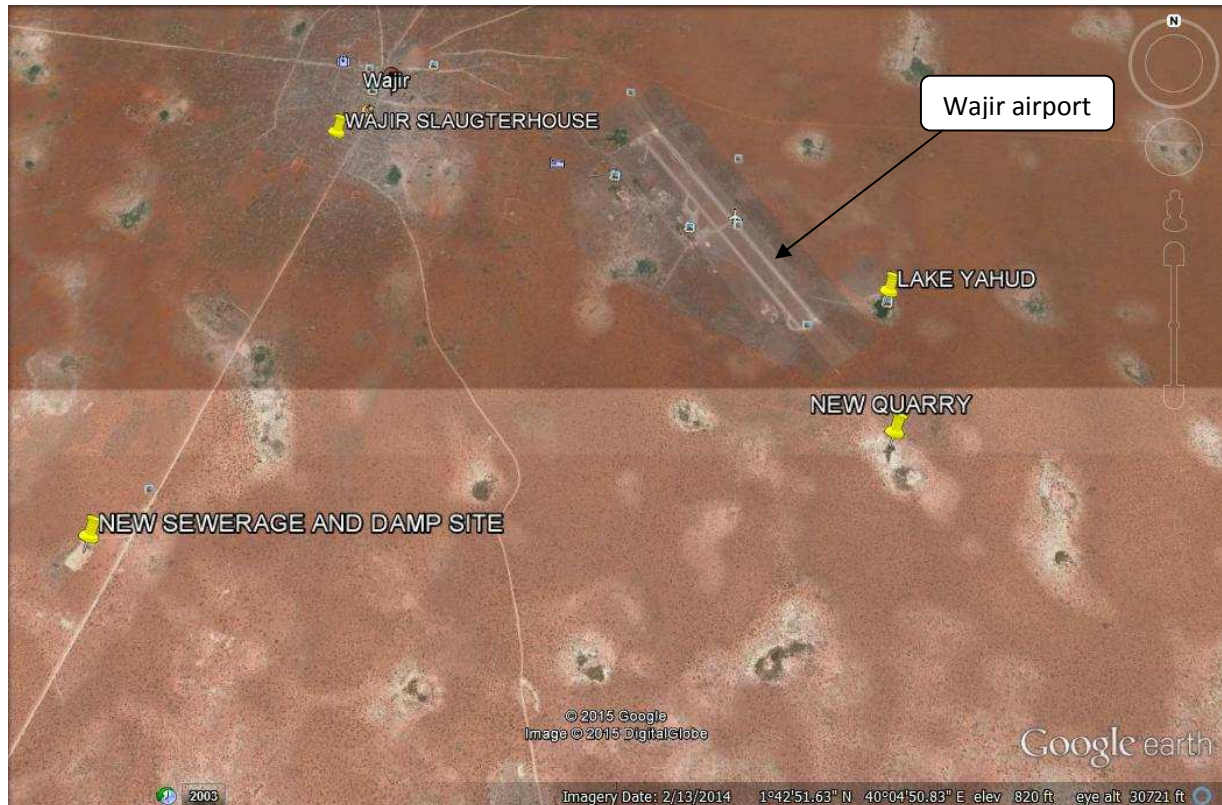
Figure 3: Google map showing Wajir aerodrome and its environs

The above Google map shows major bird/wildlife attractants around Wajir airport. Major Attractants are Wajir slaughterhouse, Lake Yahud, New quarry, new co-located sewerage and damping site. There are also other attractants within the airport such as swamp water mash, grass and bushes. All the attractants sites fall less than 7km radius from the aerodrome reference point (ARP). Lake Yahud is the nearest at 1.67km from ARP and less than 0.66km from end of runway 15.
